Remedial Action for Arroyo Hondo State Lead Site

Santa Fe, New Mexico

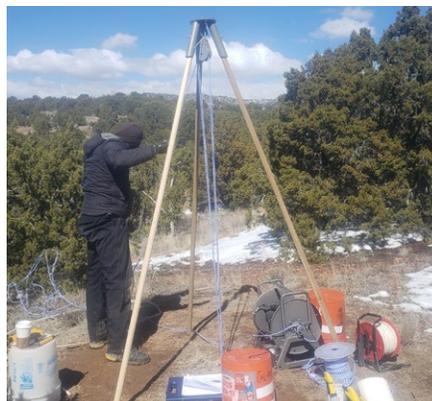
DBS&A staff conducted aquifer pumping tests to assess reasonable flow rates for groundwater extraction.

The DBS&A team also conducted aquifer pumping tests, coordinated SVE pilot testing, and synthesized the data and associated analyses to update the Final Remediation Plan (FRP) and associated engineering design documents. The FRP was updated and

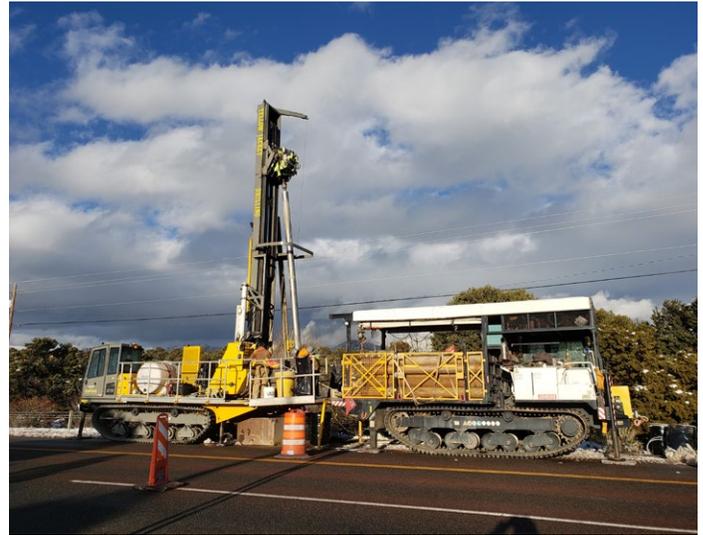
DBS&A provided oversight and CQA for the installation of 20 wells, most of which were installed in highway ROW.

using a combination of air rotary and sonic drilling technologies. Drilling locations were complicated by variable site topography, dense vegetation, and extensive highway right-of-way (ROW). DBS&A provided geologic oversight and construction quality assurance (CQA) during installation of the wells as well as regular soil and groundwater sampling.

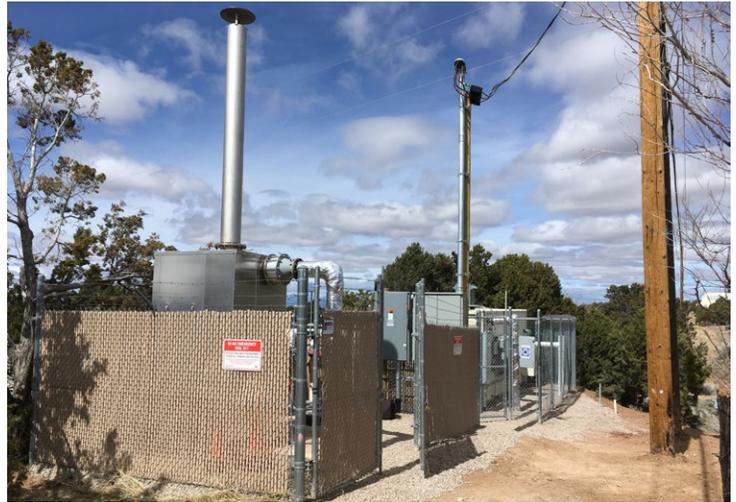
DBS&A creatively engineered larger SVE equipment to fit within a space that is shared by highway ROW and a utility corridor.

After PSTB approved the FRP, DBS&A led the effort to implement corrective action by providing construction observation, CQA, and developing as-built documentation, including record engineering drawings. DBS&A determined that the existing SVE treatment equipment had exhausted its useful life, so containerized equipment owned by NMED, including an electric catalytic oxidizer, was repurposed from another PSTB site to increase overall system capacity and minimize the overall cost to the client. The SVE blower was provided with a variable frequency drive (VFD) to provide
